Design Development – Retaining Wall Stabilization Scope Narrative

Saint Louis Zoo – Elephant Management Facility

March 21, 2025

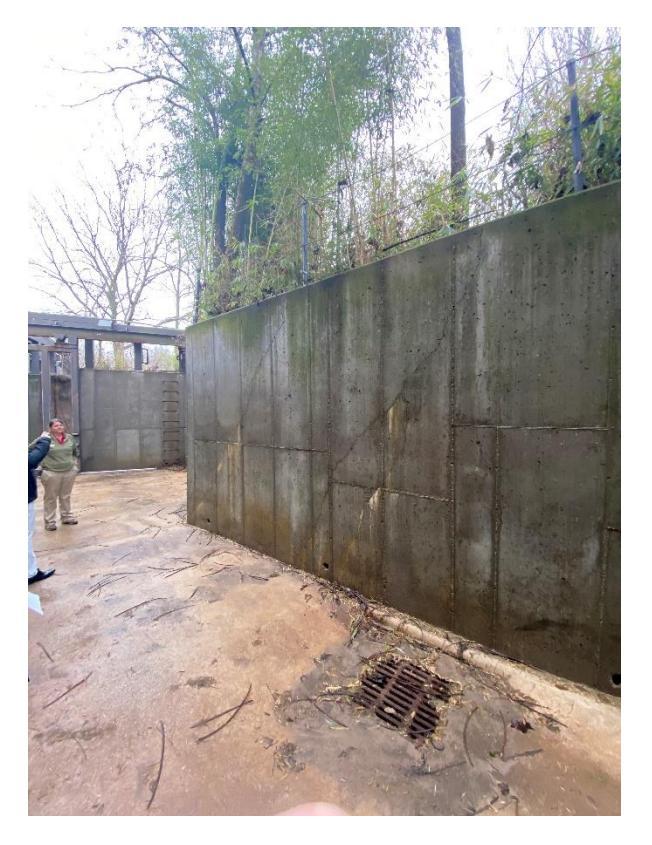
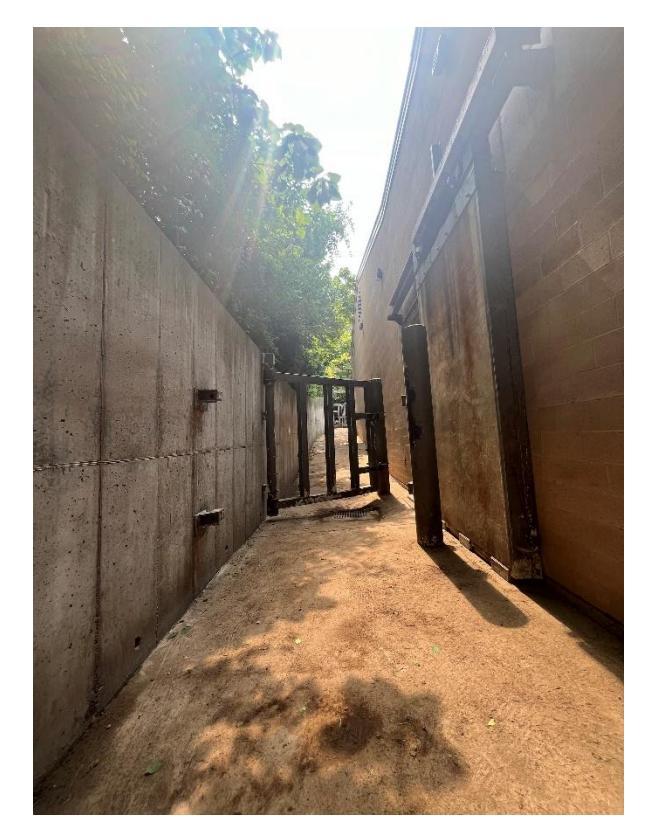
At the eastern end of the existing retaining wall, there are several large diagonal cracks in the concrete. The wall near the existing steel swing door is visibly out of plane, likely due to the added weight of the steel and hydrostatic pressure build-up on the retained earth side of the wall.

The architect and structural engineer sought the expertise of a contractor specializing in retaining walls and stabilization of existing retaining walls to confirm the appropriate stabilization scope. The retaining wall will require fifteen (15) turnbuckle anchors of varying depths depending on the actual layout of gunnite retaining wall beyond.

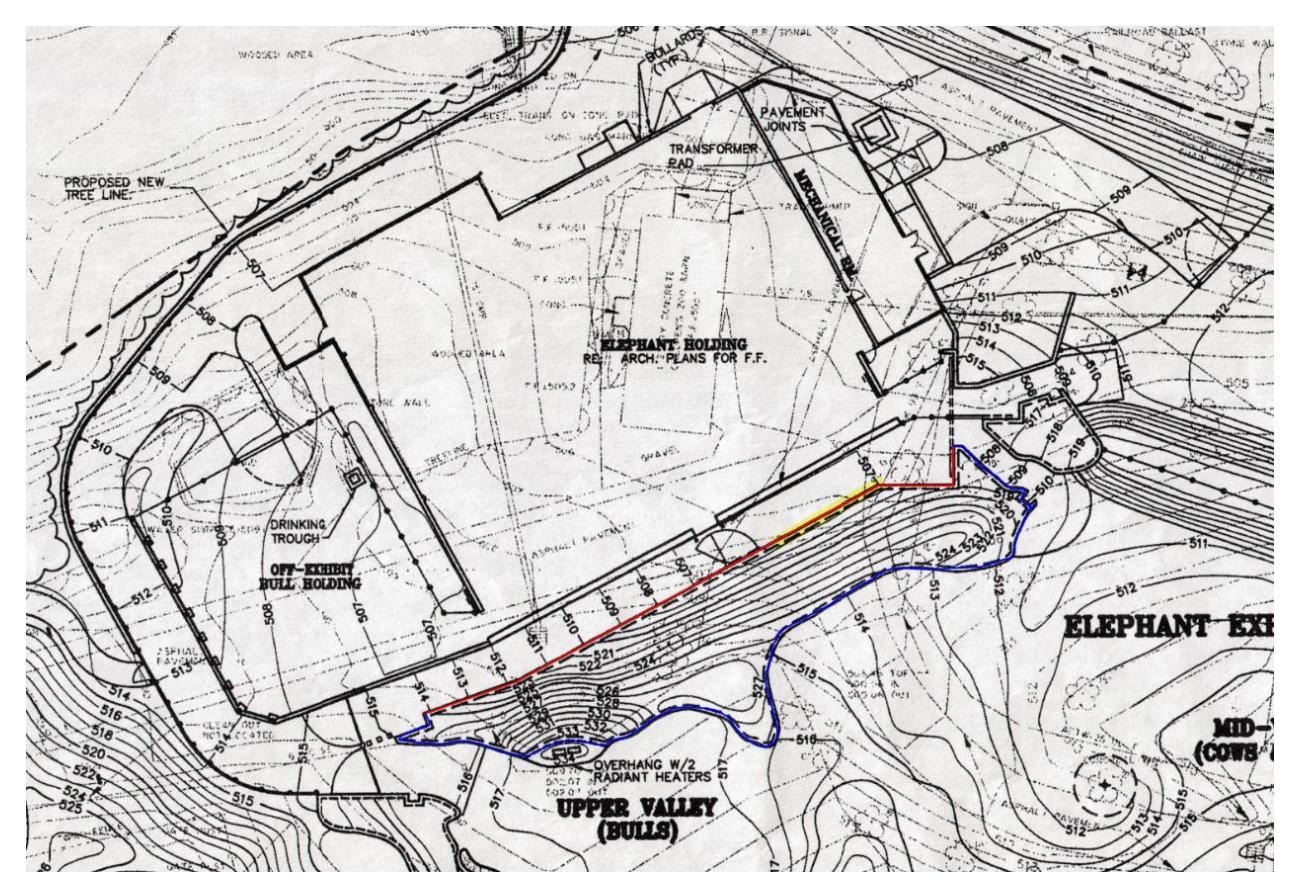
Below is the existing civil drawings of this facility. The red wall below is the concrete retaining wall in need of stabilization. The highlighted yellow portion is the part that is cracking and experiencing out-of-plane movement. The blue wall is the gunnite retaining wall in the public-facing Elephant exhibit.

The distance between these two retaining walls are +/- 20'-0" at the area in need of stabilization.
